MOUNT ZION CHURCH  
LEESBURG, VIRGINIA

PRELIMINARY STRUCTURAL EVALUATION  
OF REAR WALL DISTRESS

DECEMBER 5, 1996

Re: Mt. Zion Church  
Preliminary Structural Evaluation  
of Rear Wall Distress  
96223.

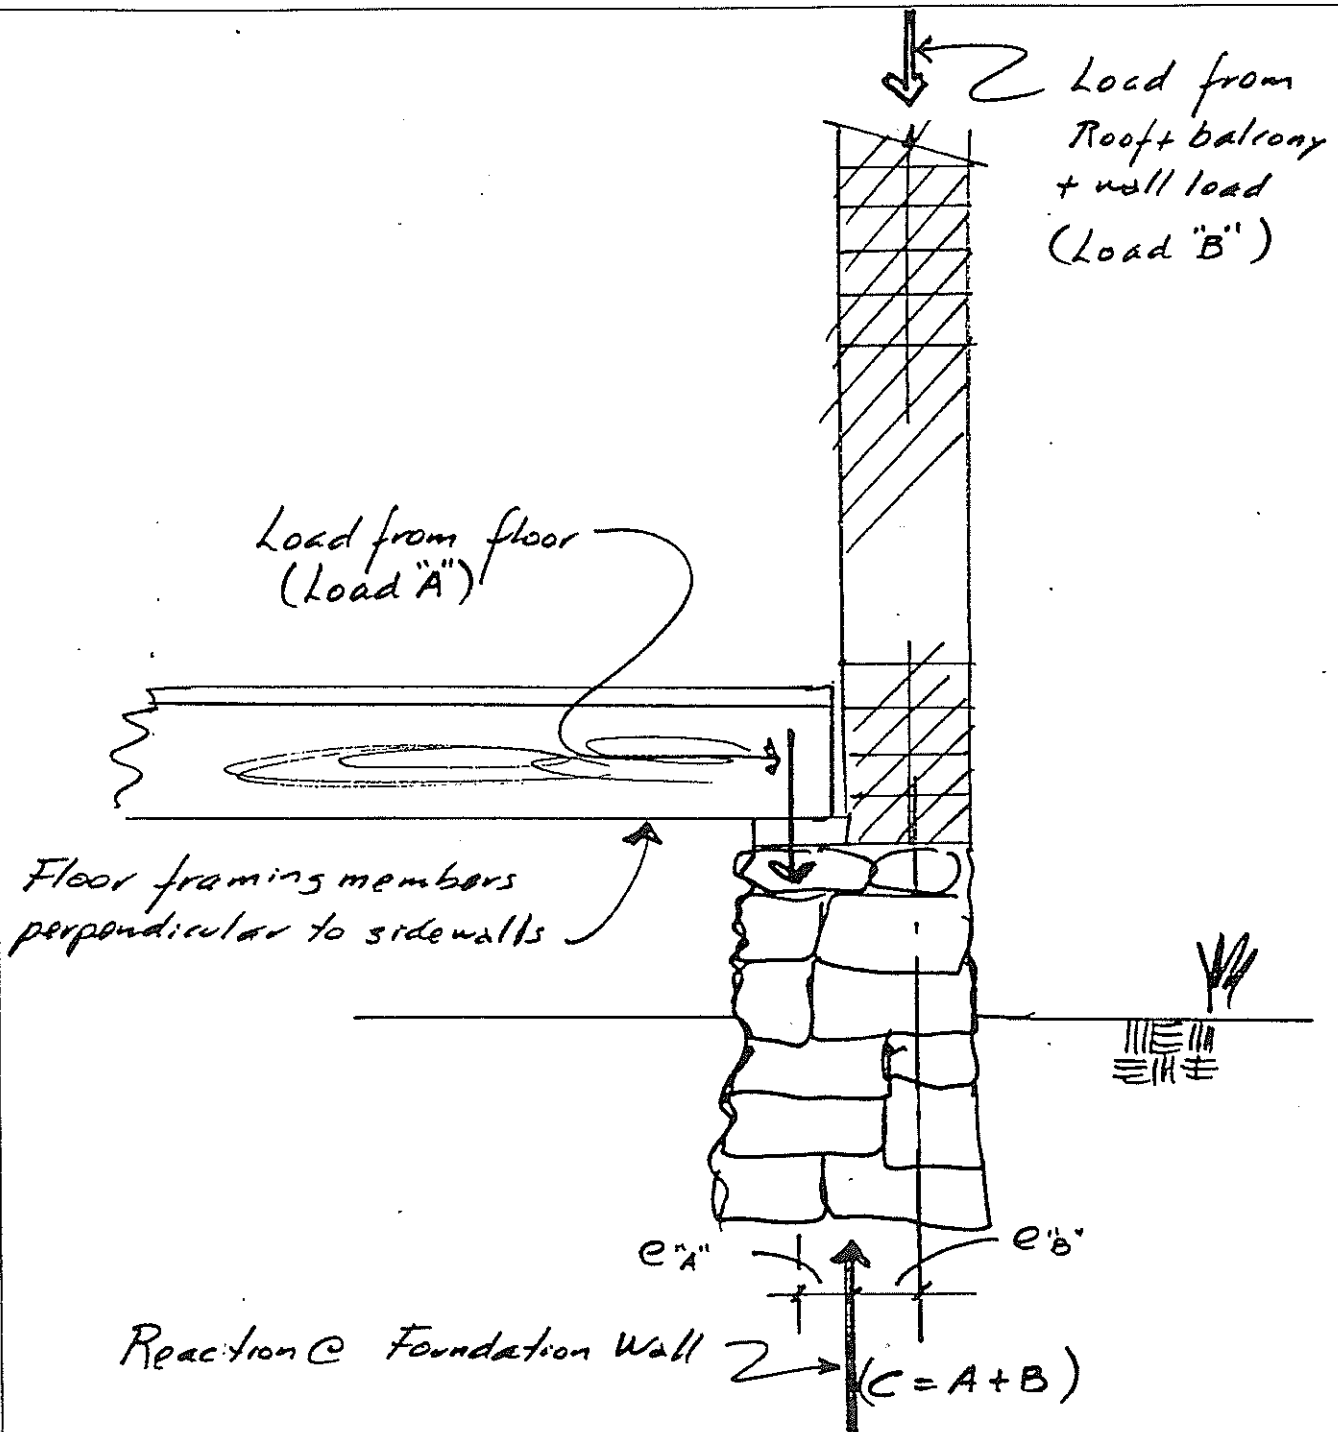
Section thru Side-Wall

Our findings could be expressed best if we first try to explain what may have caused the existing conditions. (Please refer to drawing 1 of 5).

Exterior side walls on structures dating to the original construction of this building were constructed on stone foundation walls. The stone foundation walls being wider than the walls above. The loads imposed on the outside face of these foundation walls coming from the roof and balcony framing plus the weight of the wall were partially balanced by the floor framing loads acting on the inside face of the foundation walls.

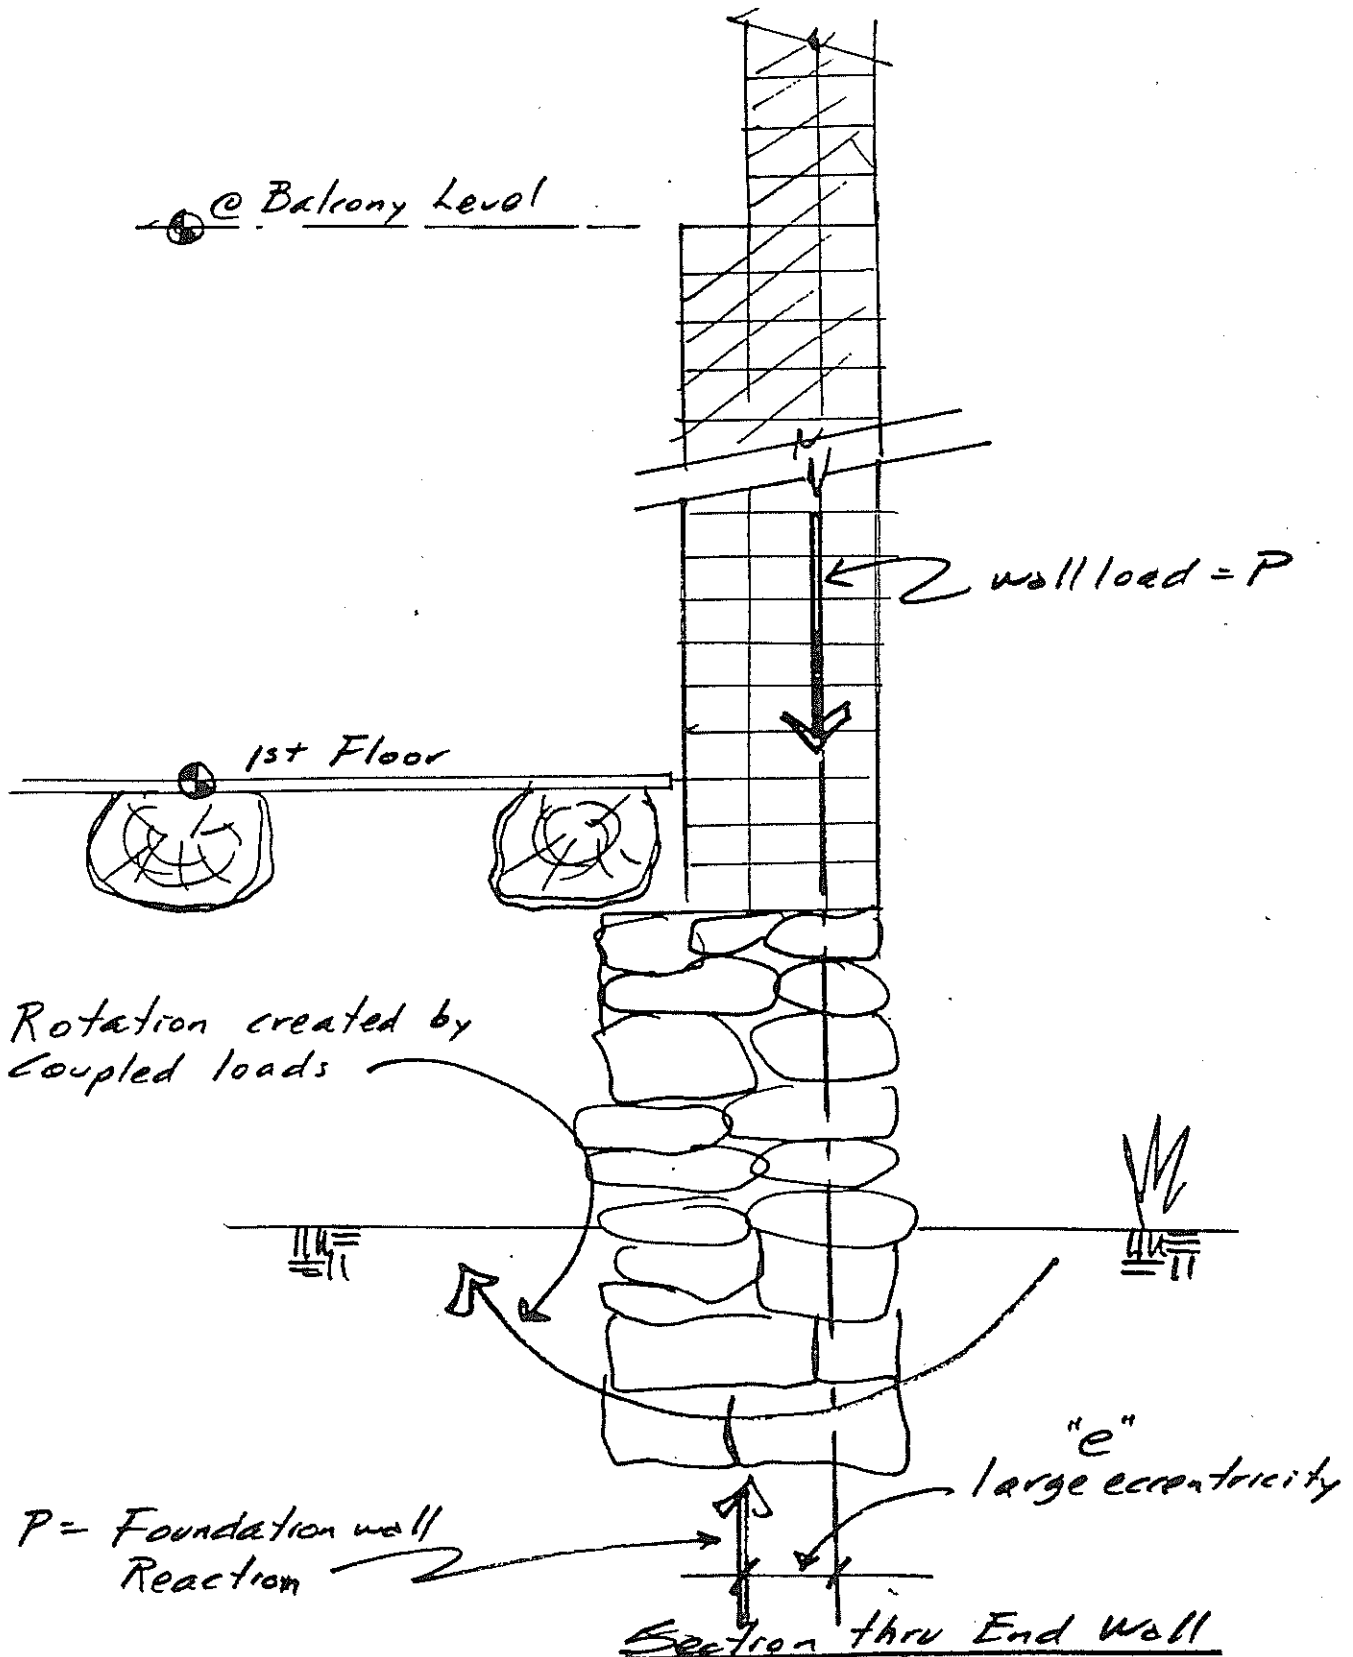
PROJECT M<sup>+</sup> Zion Church SHEET 2 OF 5  
SUBJECT Probable Section thru DATE 12/96  
End wall. BY LF  
F&A PROJECT No. 96223  
CLIENT PROJECT No. \_\_\_\_\_

We must also note that seldom if ever were footings installed under these walls. The normal construction sequence was one of excavating a trench until the ground "looked good" and then starting the foundation wall by placing some rows of flatter stones. The net result being walls partially balanced which could be damaged by erosion, animal borrows, heaving, etc. What saved most of these "old" structures, was that foundation trenches were usually excavated to three or four feet below grade. (Please refer to drawing 2 of 5).

End walls on these buildings did not enjoy the benefits of a floor loading from the inside balancing the eccentric loads generated by the exterior walls, thus it is quite common to find rotating end walls associated with these structures.

In the case of the Mt. Zion Church, these facts associated with poor drainage, a change in width of the end wall, (8" to 12"), and the fact that the stone foundation walls were always built wider than the supported brick walls, and were most of the time built flush with the upper brick walls, have created an extraordinarily large eccentric loading on the footing.
